Community Development Committee

MEETING AGENDA

March 26, 2024

## **Structural Evaluation of Livery Stable at 23 East Main Street, Berryville, VA *Final Submission***

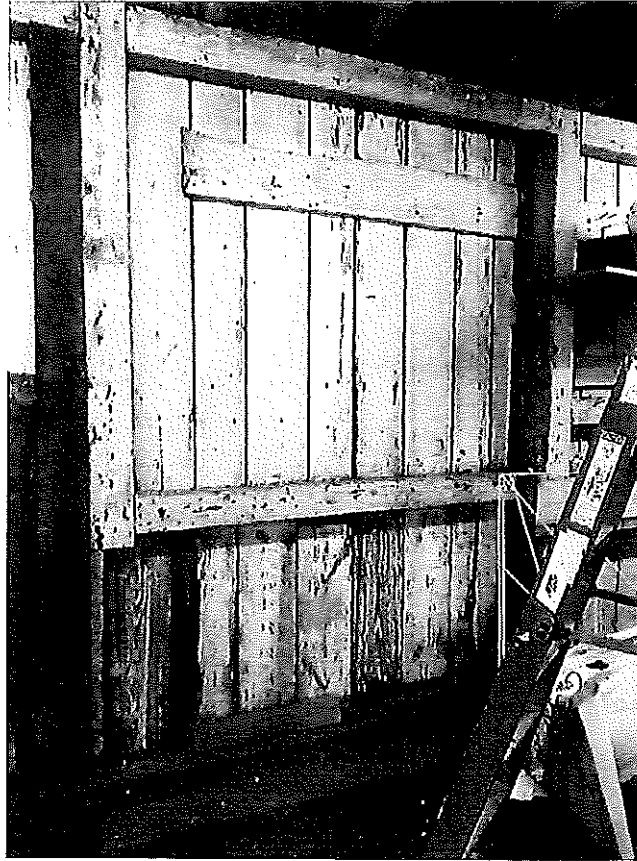
Below the floor beam, significant modifications to the wall framing has been made. It is unclear as to the reasoning behind these modifications. Each of the columns have been cut to different lengths and propped by multiple members. Between the columns below the floor beam random wall girts have been installed. These girts, and the framing supporting the columns, are fastened with wire nails, indicating work completed since the early 1900's. All of the new members' bear on a solid sawn 2-inch by 8-inch wood plate that is attached to a cast-in-place stem wall. The concrete stem wall abuts the existing building to the north and travels south to within 12 inches of the southwest corner of the building. As with the other columns along this

wall, the corner column has been cut with multiple members attached to it and carrying it to grade where it rests on stones from an original foundation wall.

*Figure 5 - West wall framing example below floor.*

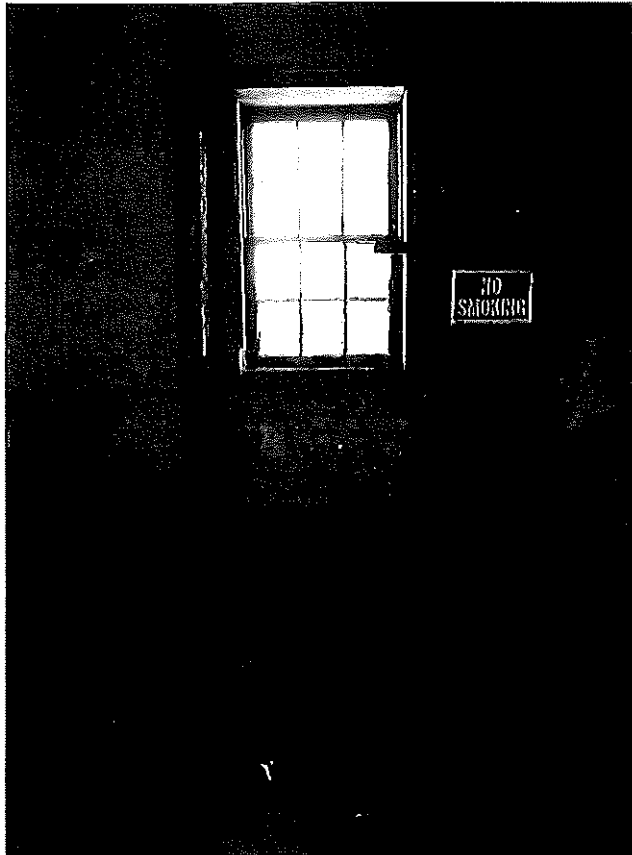
The wall is constructed of a multi-wythe common (American) bond with a header course every six courses. The brick wall is supported by a stone foundation wall. Window openings on the at-grade level of the Stable utilize a Jack Arch to support the loads above. The window on the upper floor is flush to the rafter bearing assembly. The wall is continuous from the level of the stone foundation to rafter bearing. On the visible portions of the wall it is evident that the interior

face has been skimmed with a coating of mortar/plaster. It covers the entire exposed area of the second floor. On the at-grade level the coating is only visible on a small portion of the wall, but there are indications that it covered the entire wall at one time. The exterior surface of the wall has been painted in its entirety.

*Figure 6 - Brick deterioration on east wall below floor.*

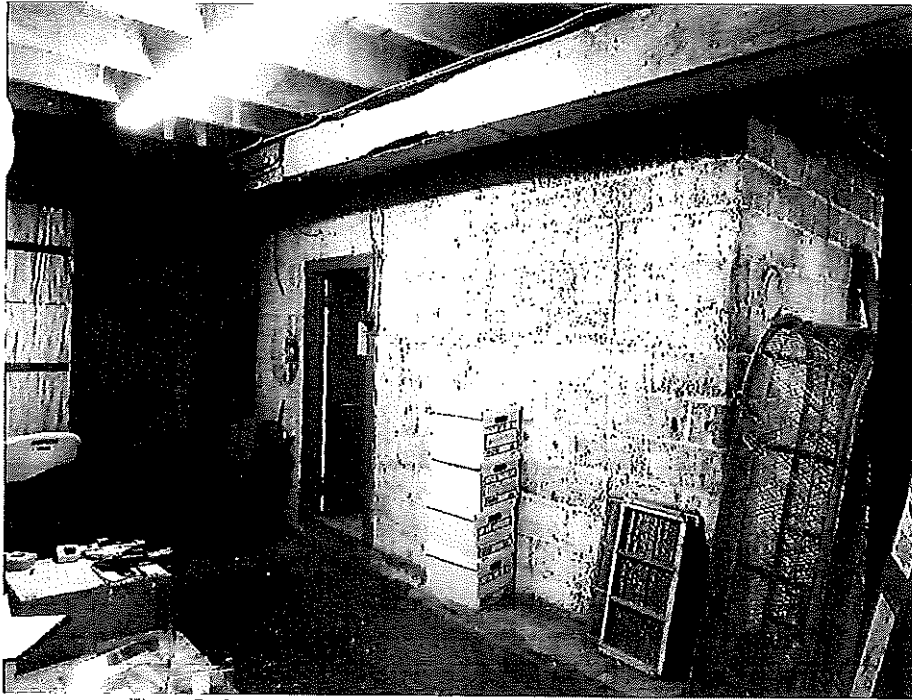
On the second level the partitions are framed of solid sawn 2-inch by 4-inch members resting on a 4-inch by 6-inch bottom plate. On the at-grade level, 4-inch concrete masonry units form the interior partitions. These partitions rest on a cast-in-place concrete slab.

*Figure 7 - Interior CMU partition, settlement cracking both sides of corner.*
