Community Development Committee

MEETING AGENDA

Structural Evaluation of Livery Stable at 23 East Main Street, Berryville, VA *Final Submission*

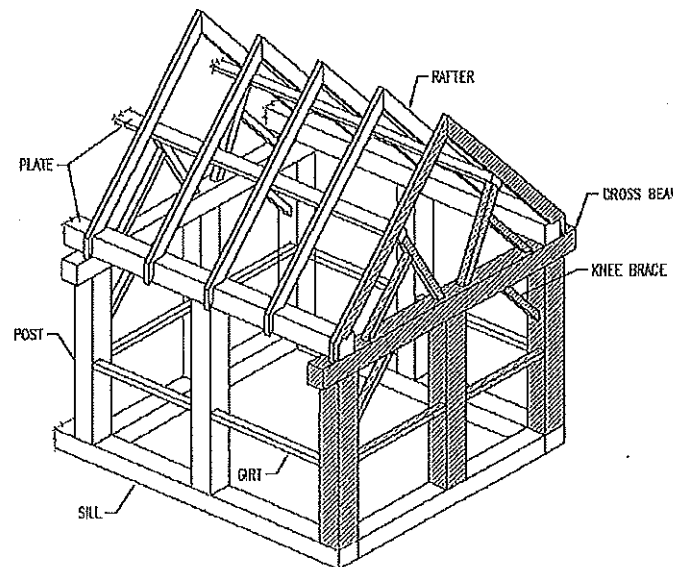
Figure 1 - Timber Frame Terminology

The barn has undergone multiple renovations and currently has both timber and masonry load bearing elements. Timber framing was the primary construction method used in the United States in the 1700's and 1800's until balloon framing began to be more popular in the mid 1800's. Timber framing uses larger wood members spaced at larger intervals and are joined with wood connections. Wood connections typically are comprised of mortise and tenon joinery. The mortise (female) is the space in timber A that receives the tenon (male) from timber B. Tenons are typically 1-2" wide and are centered on the end of the timber. Both the mortise and tenon have holes so that a trunnel (peg) is inserted to keep the two timbers joined. Figure 1 is a diagram depicting common timber frame members and their terminologies, the shaded members in the diagram all together constitute a bent. The Stable was originally constructed of two interior and two gable end bents.

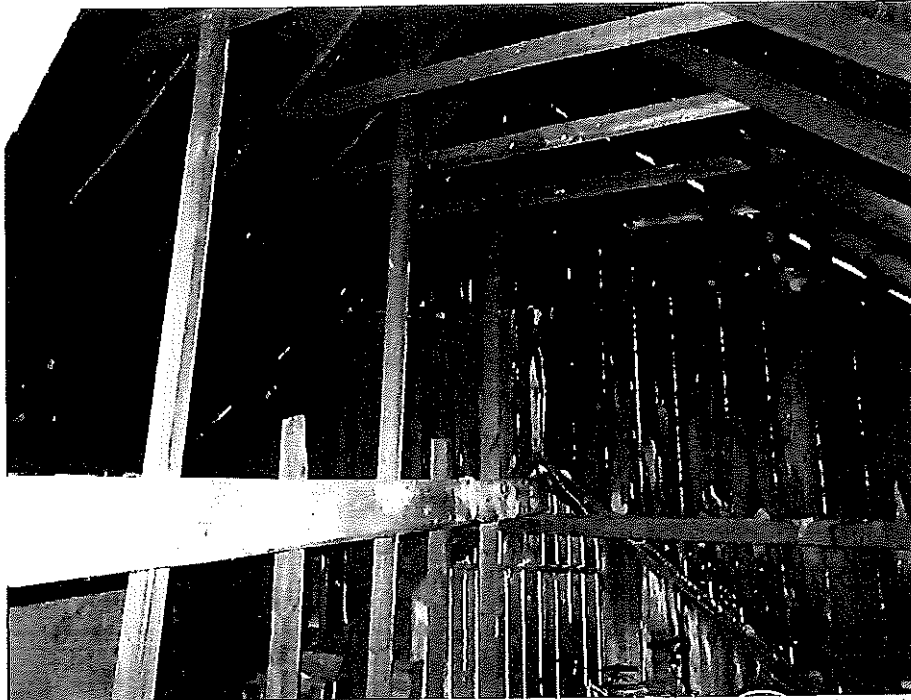
Figure 2 - Roof framing showing rafters, collar ties, and additional framing elements

Rafters make up the primary structural element for the roof system. The rafters are solid sawn 2 inch by 5 inch boards and are spaced 2 feet on center. At the peak of the roof the rafters are miter cut to the roof pitch and fastened together. To restrain lateral forces at the base of the rafter each pair is tied together with a 1 inch by 4-inch collar tie located 3 feet 10 inches below the bottom of the peak joint. Additionally, at alternating pairs the peak is reinforced with a solid sawn 1-inch by 10-inch board nailed to the southern face of the peak and a 2-inch by 4-inch vertical that runs from the peak to the floor system. The rafters bear on solid sawn beams that will be described in the wall systems.

Based on the visual observations, framing members making up the roof system appear to be sound and capable of withstanding snow loads applied to the system.

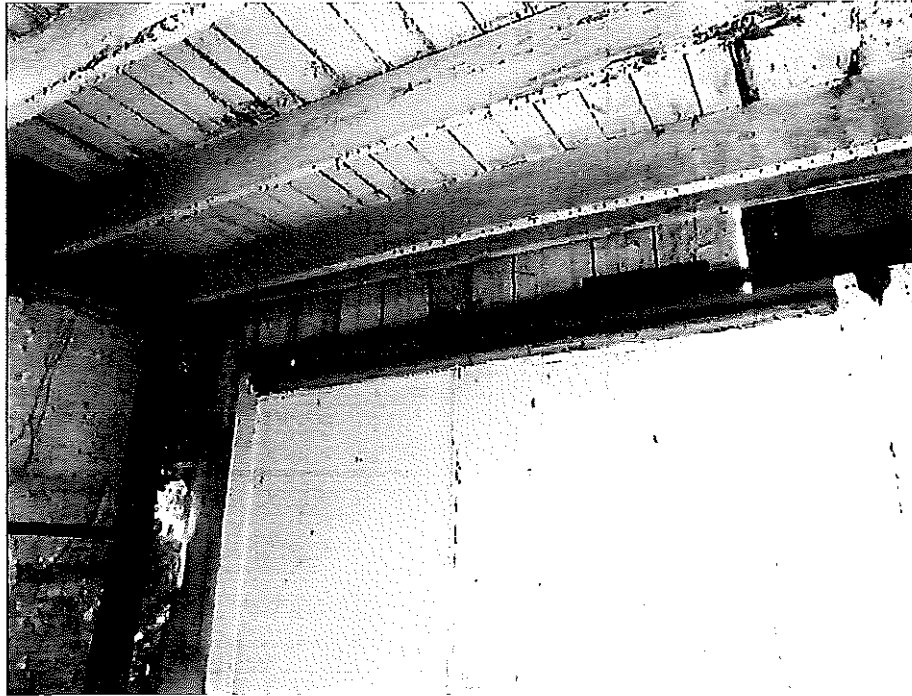
Figure 3 - View of floor framing.

The wearing surface for the floor system is comprised of 1-inch nominal planks attached to floor joists. These planks are butted together to form a continuous surface. In the finished space for the upper level an additional layer of plywood has been installed for a smooth wearing surface. A floor hatch was installed to allow access to the at-grade level just outside the door from the finished to unfinished area of the second floor. This hatch attaches to the top side of the decking with the opening framed between two floor joists. The only deficiency noted in the floor

The wearing surface is supported by solid sawn floor joists. Joists bearing on the east wall of the building are 2-inch by 8 7/8-inch boards that bear in joist pockets in the brick wall. Joists bearing on the west wall are 2-inch by 10-inch members bearing on a 4-inch by 6-inch beam framed into the wall system. A transition in the floor is made roughly 12 feet 5 inches from the inside face of the east wall. At this transition the joists bearing on the western wall are stacked on top of those from the east. This transition results in an 11-inch step in the floor. The floor is supported at the transition by two separate means. First, by the concrete masonry wall that forms the electric room and bathroom. And second, south of the masonry wall, a flat 2-inch by 8-inch board supported by four columns with varied spacing. An additional flat support beam was also installed four inches away from the face of brick, it is also supported by columns, five with varied spacing.

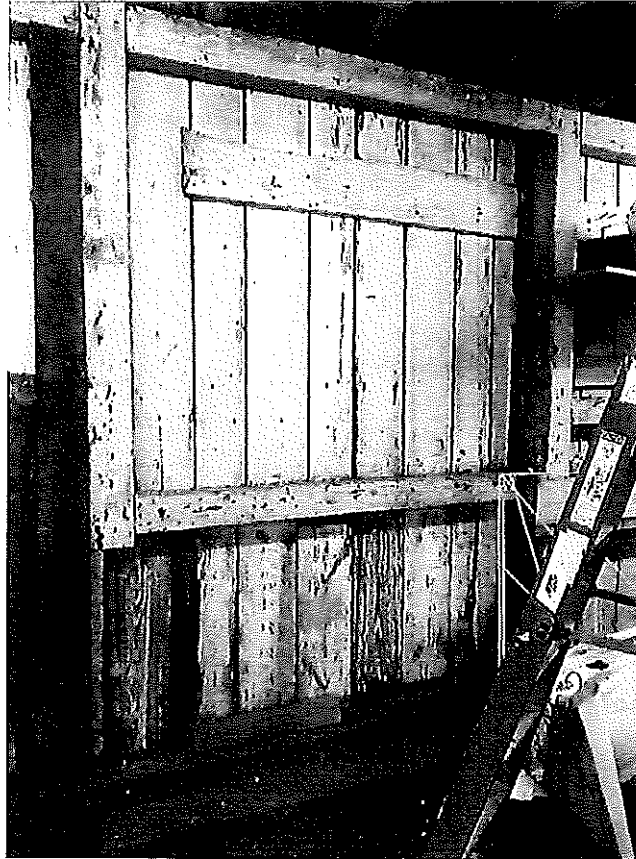
Figure 5 - West wall framing example below floor.

Below the floor beam, significant modifications to the wall framing has been made. It is unclear as to the reasoning behind these modifications. Each of the columns have been cut to different lengths and propped by multiple members. Between the columns below the floor beam random wall girts have been installed. These girts, and the framing supporting the columns, are fastened with wire nails, indicating work completed since the early 1900's. All of the new members' bear on a solid sawn 2-inch by 8-inch wood plate that is attached to a cast-in-place stem wall. The concrete stem wall abuts the existing building to the north and travels south to within 12 inches of the southwest corner of the building. As with the other columns along this

wall, the corner column has been cut with multiple members attached to it and carrying it to grade where it rests on stones from an original foundation wall.

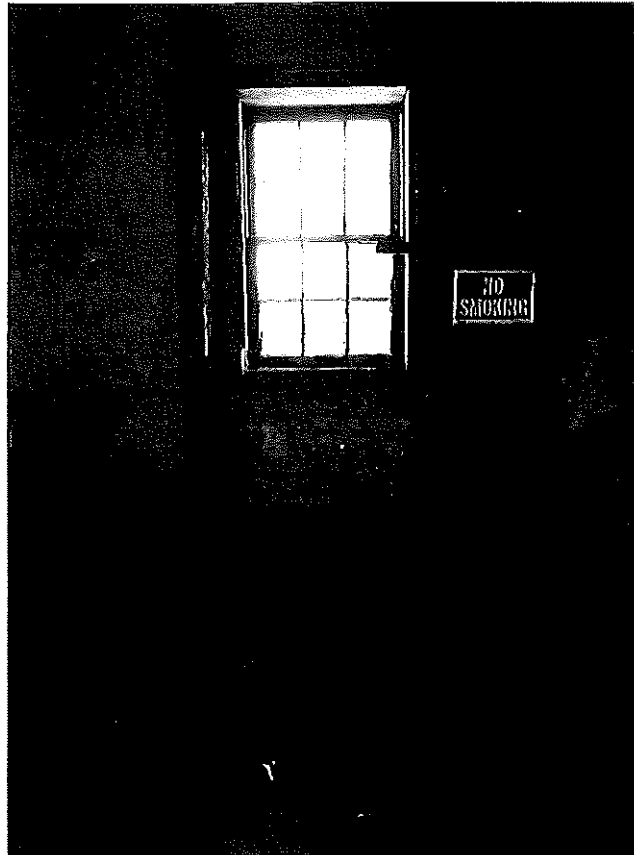
Figure 6 - Brick deterioration on east wall below floor.

- a. Mortar/plaster skim coat above the second floor has multiple floor to top of wall cracks and shows signs of delaminating from the wall bricks.
- b. Mortar/plaster skim coat delaminating on the remaining wall surfaces that have it.
- c. Mortar joint deterioration resulting from water infiltration or salt accumulation requiring 100 square feet of joint replacement/repointing. This deterioration has resulted in bricks loosening and dislodging from the wall.
- d. Coving and crumbling of bricks on the interior wythe below the southernmost window of the wall. Most likely caused by water infiltration.

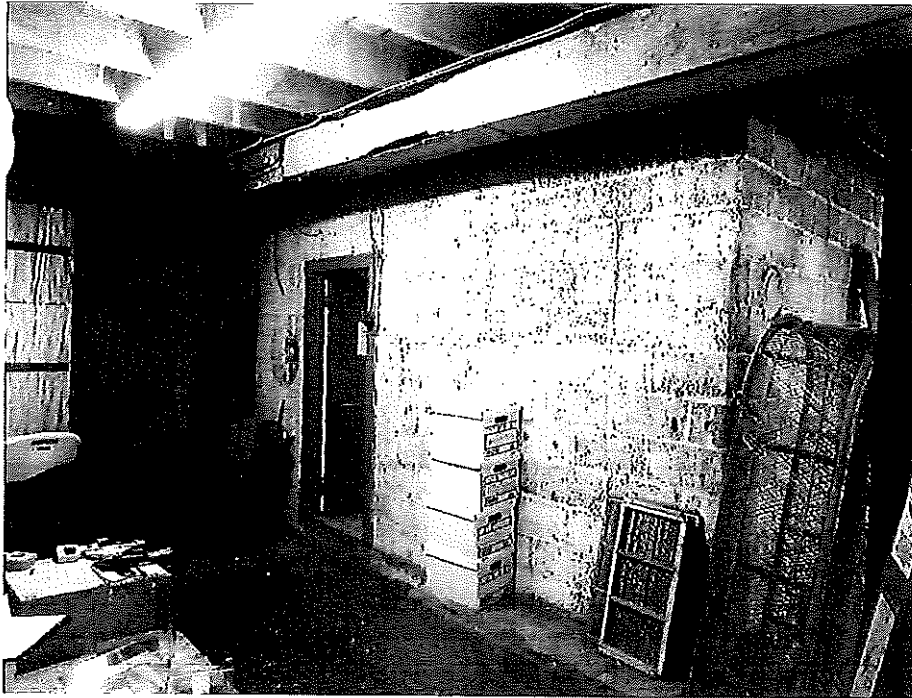
Figure 7 - Interior CMU partition, settlement cracking both sides of corner.

On the second level the partitions are framed of solid sawn 2-inch by 4-inch members resting on a 4-inch by 6-inch bottom plate. On the at-grade level, 4-inch concrete masonry units form the interior partitions. These partitions rest on a cast-in-place concrete slab.

- a. The exterior wall of the finished area on the second floor shows evidence of animal infestation/nesting.
- b. Settlement crack visible emanating from western corner of the south concrete masonry wall.

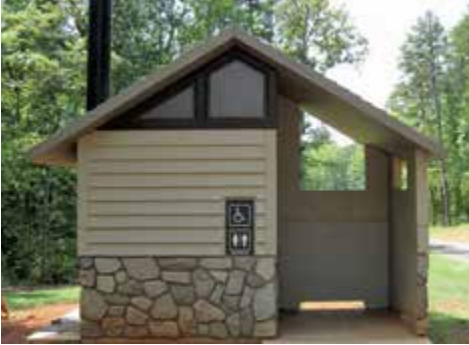
ROCKY MOUNTAIN

- 1 single user waterless restroom
- 6' 6" x 14' 8" floor plan
- 1 ADA toilet riser with seat
- ADA grab bars
- 1 waste clean out hatch
- 1- 1,000 gallon concrete waste vault

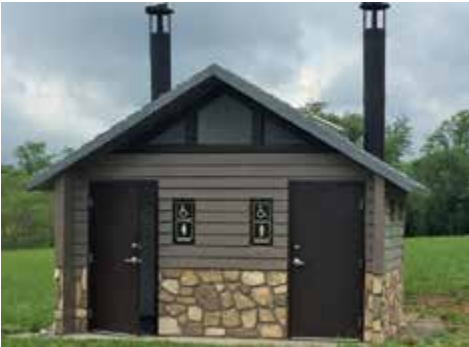
DOUBLE ROCKY MOUNTAIN

- 2 single user waterless restrooms
- 11' 11" x 14' 4" floor plan
- 2 ADA toilet risers with seat
- ADA grab bars
- 2 waste clean out hatches
- 2- 1,000 gallon/each concrete waste vault

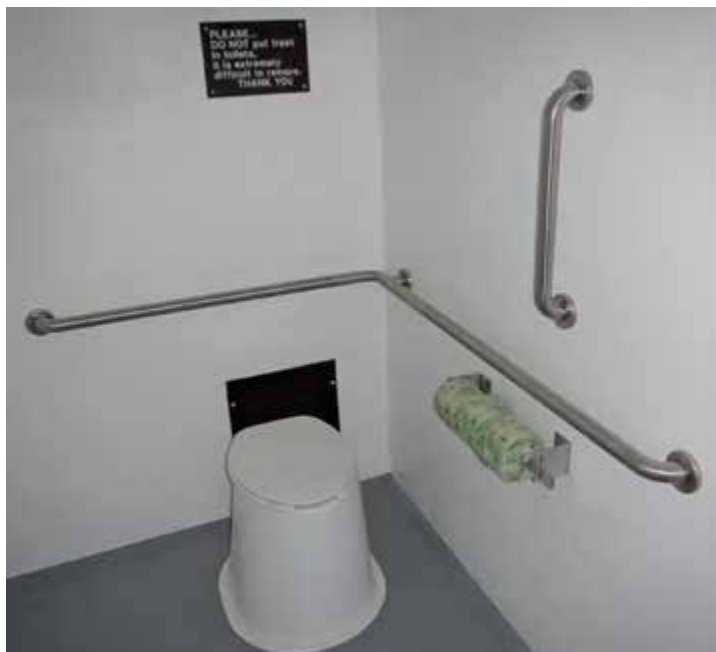
A full length and width concrete vault lined with a black polyethylene liner that is cast into the side walls of the concrete vault using dovetail embeds provides a dual containment vessel for waste.

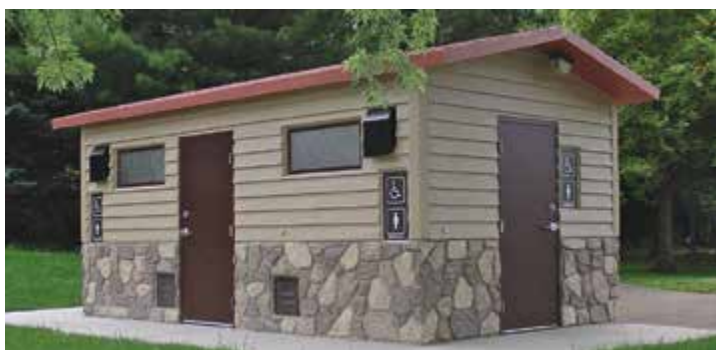
OZARK II

- 2 single user flush restrooms
- 10' 6" x 18' 8" floor plan
- Interior & exterior lights
- 2 ADA toilets
- 2 sinks
- ADA grab bars

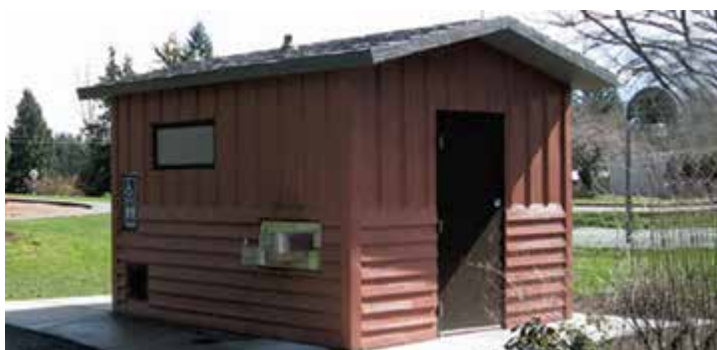
OZARK I

- 1 single user flush restrooms
- 10' 6" x 12' floor plan
- Interior & exterior lights
- 1 ADA toilet
- 1 sink
- ADA grab bars

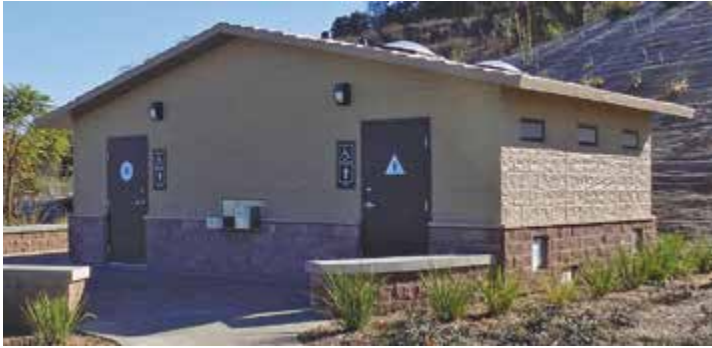
MONTROSE

- 2 multi user flush restrooms
- 15' 8" x 26" floor plan
- Interior & exterior lights
- 3 toilets (2 ADA)
- 1 urinal
- 2 sinks
- ADA grab bars

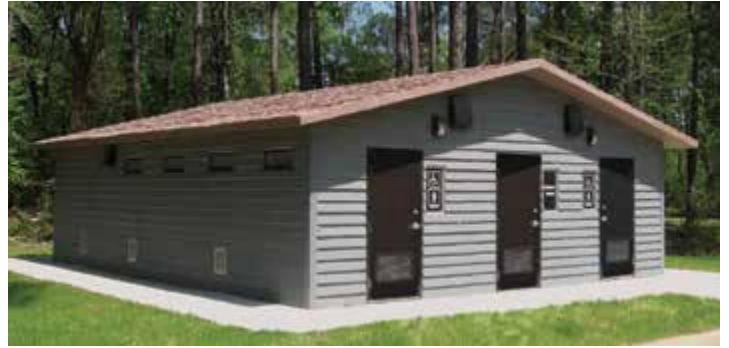
ARAPAHOE

- 4 family assist restrooms
- 20' x 26' floor plan
- Interior & exterior lights
- 4 ADA toilets
- 1 urinal
- 4 sinks
- ADA grab bars

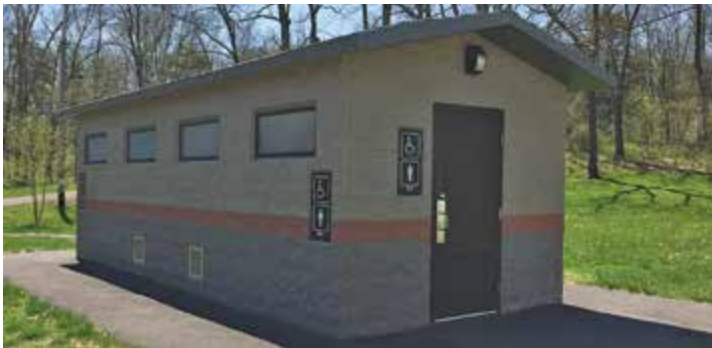
KODIAK

- 2 multi user flush restrooms
- 10' 6" x 23' 8" floor plan
- Interior & exterior lights
- 3 toilets (2 ADA)
- 1 urinal
- 2 sinks
- ADA grab bars

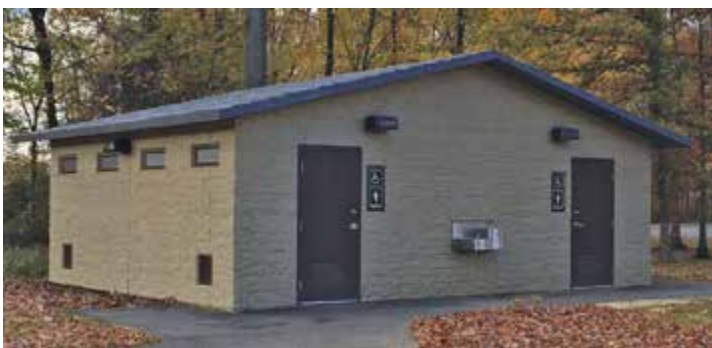
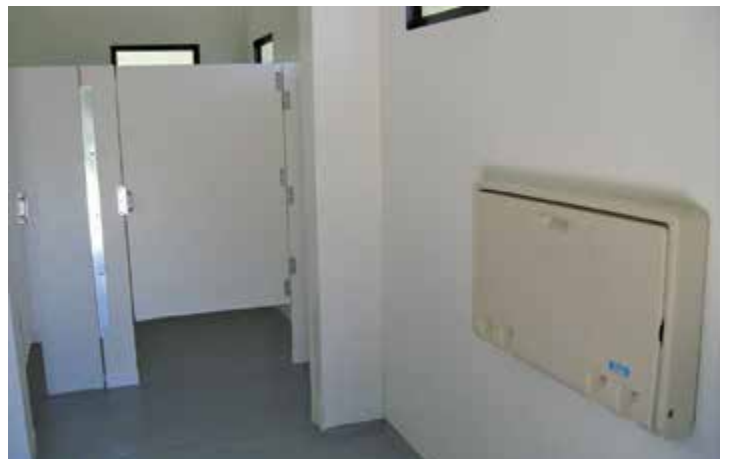
TAOS

- 2 multi user flush restrooms
- 20' x 26' floor plan
- Interior & exterior lights
- 5 toilets (2 ADA)
- 1 urinal
- 2 sinks
- ADA grab bars

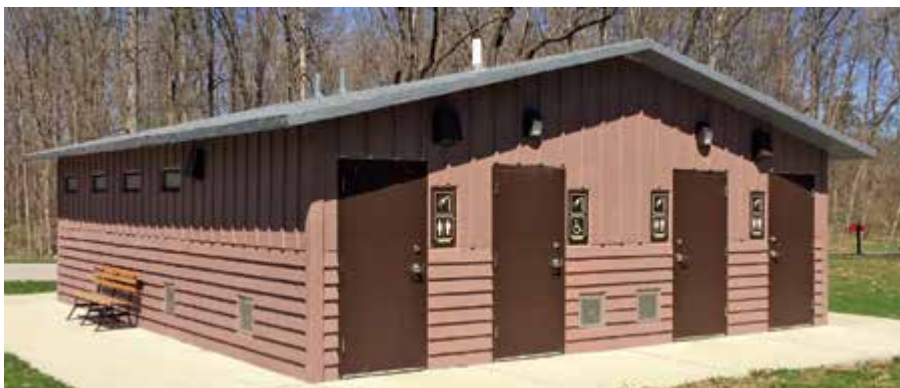
CHEYENNE

- 2 multi user flush restrooms
- 4 separate shower rooms (1 ADA)
- 26' x 30' floor plan
- Interior & exterior lights
- Water heater
- 5 toilets (2 ADA)
- 1 urinal
- 4 sinks
- ADA grab bars

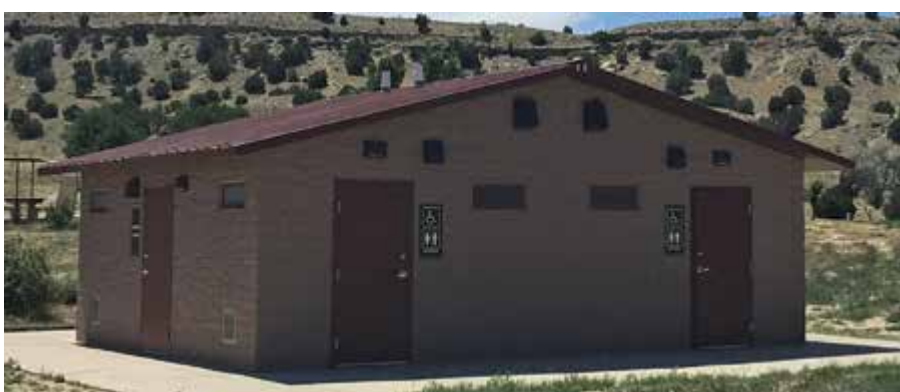
NAVAJO

- 4 individual family assist flush restrooms and showers
- 20' x 26' floor plan
- Interior & exterior lights
- Water heater
- 4 ADA toilets
- 4 sinks
- ADA grab bars

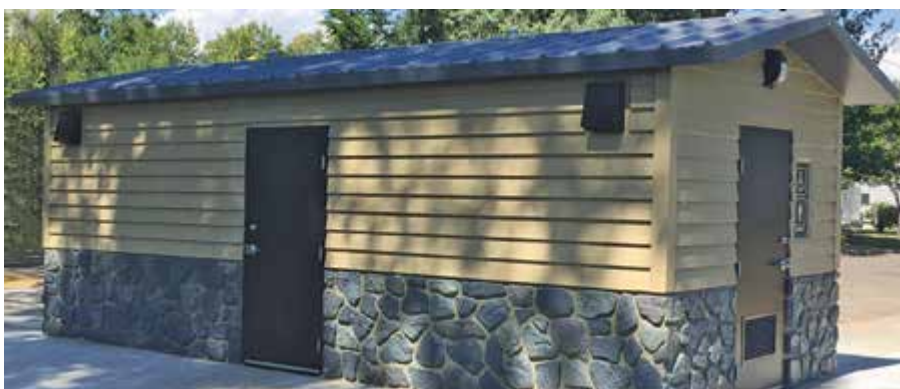
RAINIER

- 2 single user flush restrooms and showers
- 10' 6" x 23' 8" floor plan
- Interior & exterior lights
- Water heater
- 2 ADA toilets
- 2 sinks
- ADA grab bars

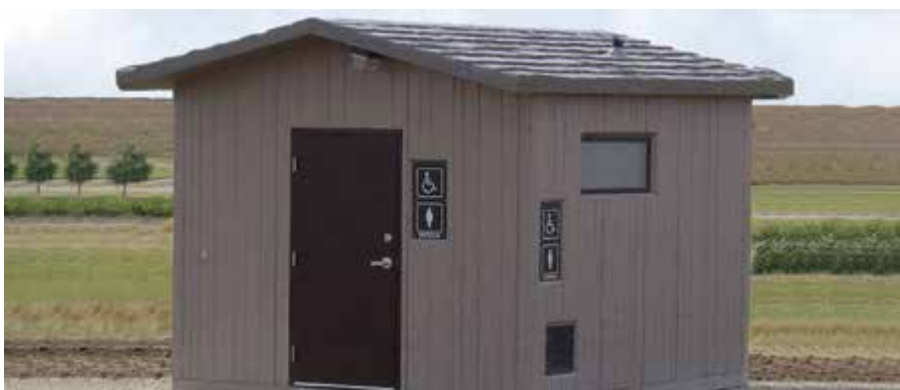
PIONEER

- 1 single user flush restroom and shower
- 10' 6" x 12' floor plan
- Interior & exterior lights
- Water heater
- 1 ADA toilet
- 1 sinks
- ADA grab bars

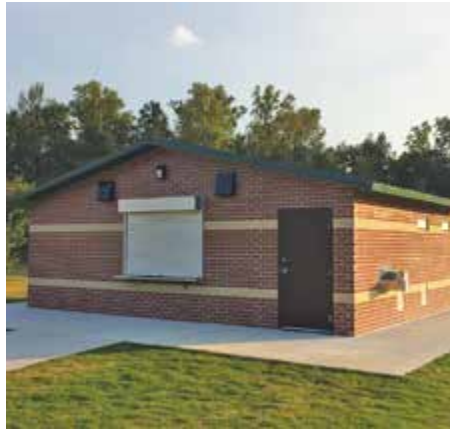
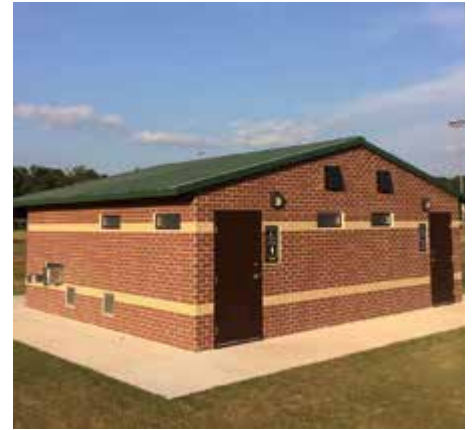
KEYSTONE

- 2 multi user flush restrooms with concession
- 10' x 26' floor plan
- 3 toilets (2 ADA)
- 1 urinal
- 2 sinks
- ADA grab bars
- 6' roll-up concession door
- 3-compartment stainless steel sink
- Interior & exterior lights

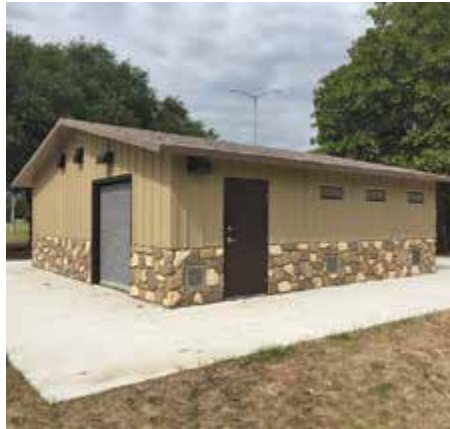
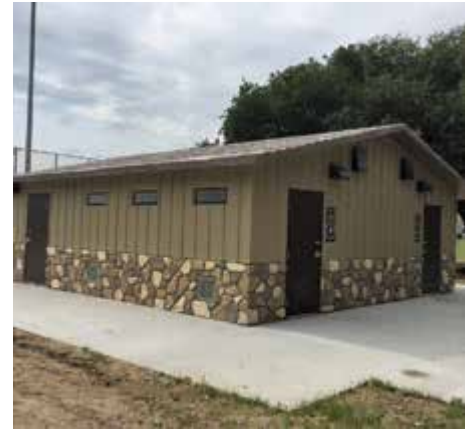
MALIBU

- 2 multi user flush restrooms with concession
- 25' 8" x 26' 4" floor plan
- 3 toilets (2 ADA)
- 1 urinal
- 2 sinks
- ADA grab bars
- 6' roll-up concession door
- 3-compartment stainless steel sink
- Interior & exterior lights

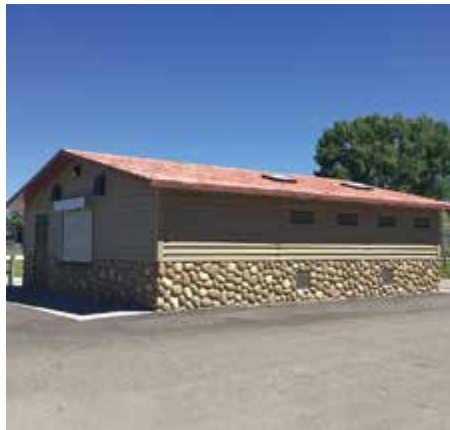
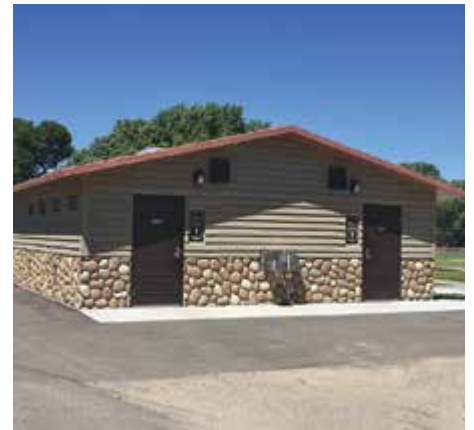
POMONA

- 2 multi user flush restrooms with concession
- 30' x 26' floor plan
- 5 toilets (2 ADA)
- 1 urinal
- 4 sinks
- ADA grab bars
- 6' roll-up concession door
- 3-compartment stainless steel sink
- Interior & exterior lights

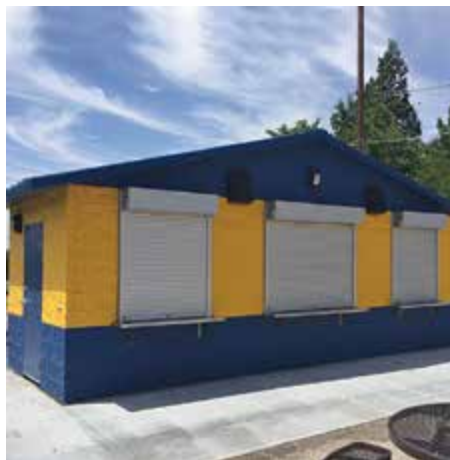
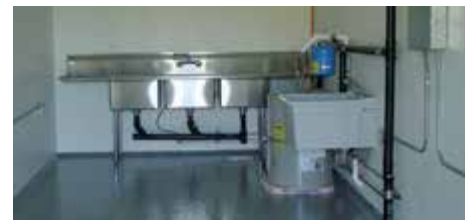
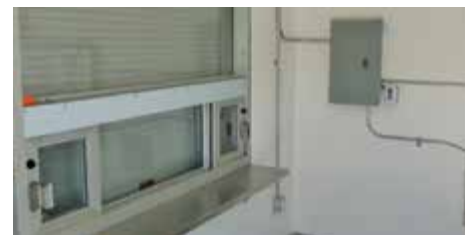
FONTANA

- Concession building
- 10' x 26' floor plan
- 6' roll-up concession door
- 3-compartment stainless steel sink
- Interior & exterior lights

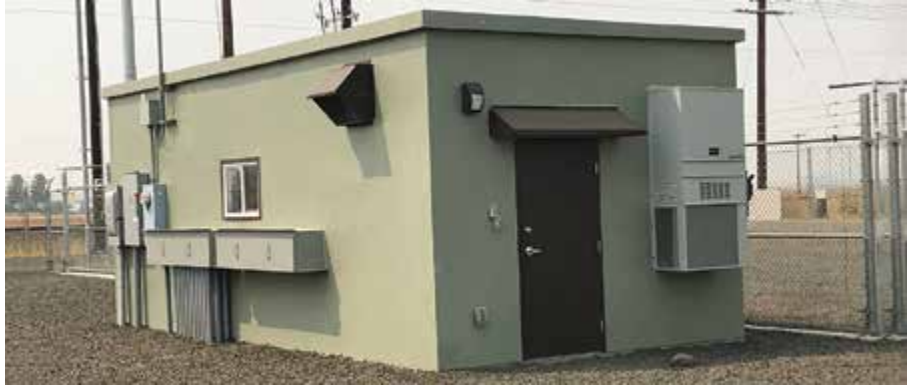
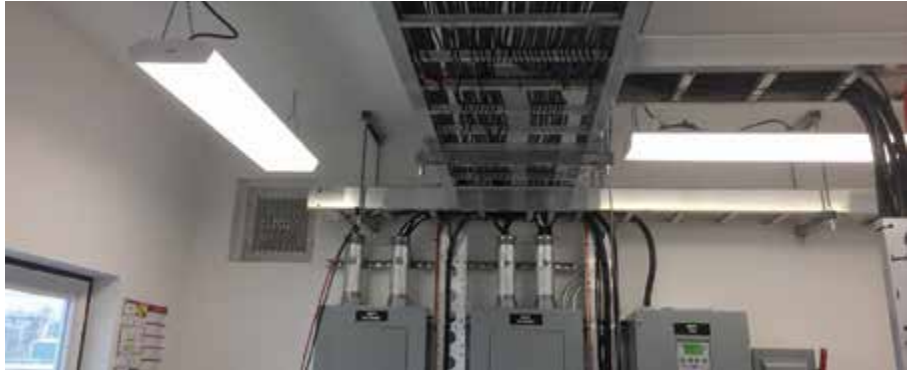
MULTIPURPOSE BUILDINGS

- Two standard sizes
 - 10' 6" x up to 12'
 - 10' 6" x 12' to 20'
- Galvanized 3068 steel door
- Wall vent
- **Customizable to accommodate a variety of uses**

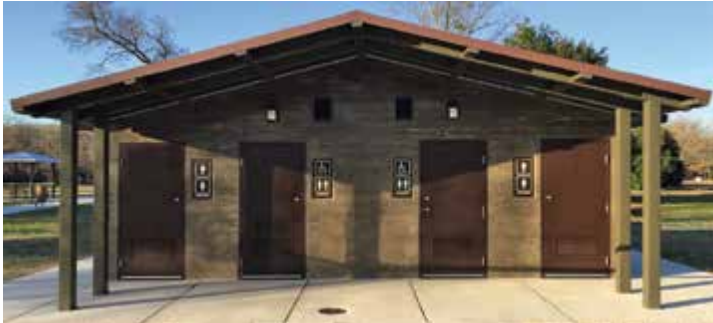
Flush restroom with custom simulated wood texture and awning

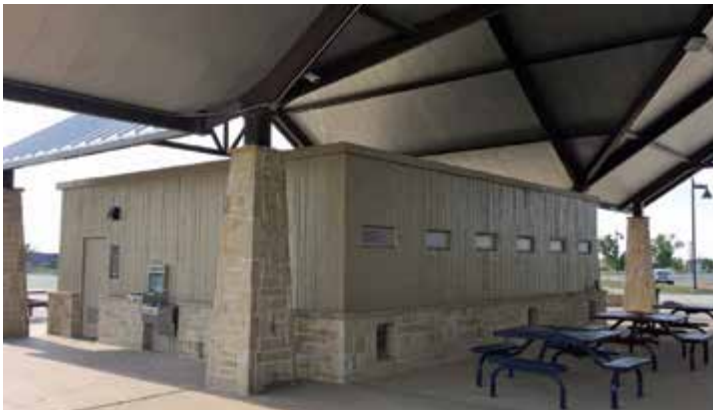
Flush restroom with custom stone texture and flat roof

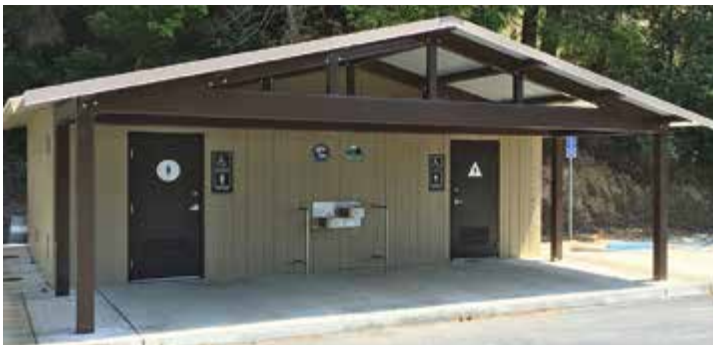
Flush restroom with custom awning

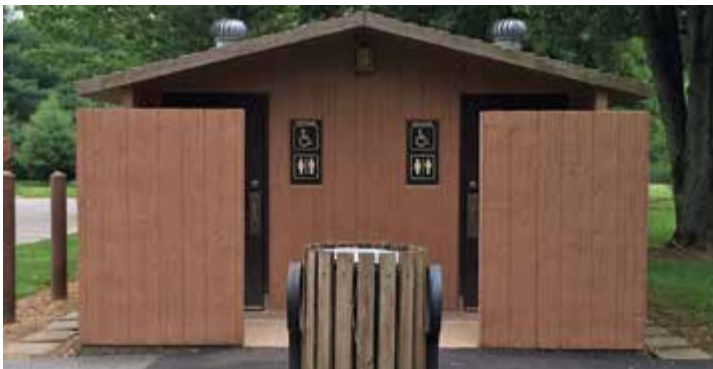
Double vault restroom with privacy screen

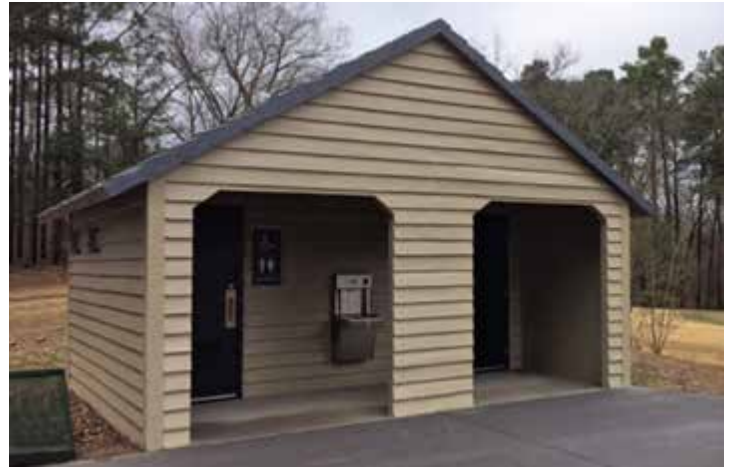
Flush restroom with custom golf cart shelter

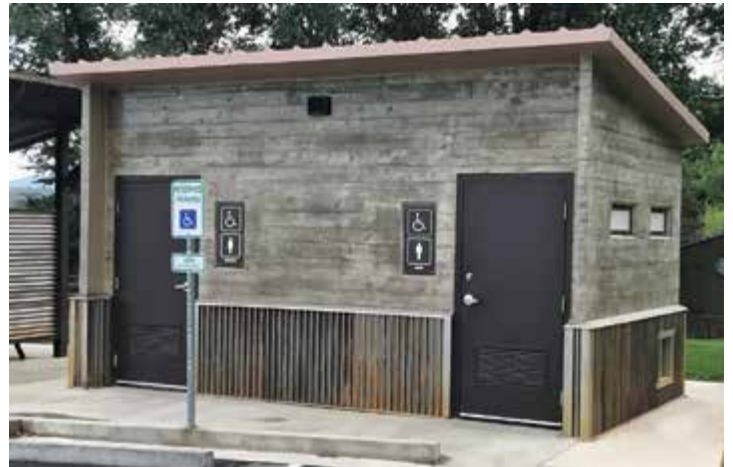
Flush restroom with custom texture and roof pitch

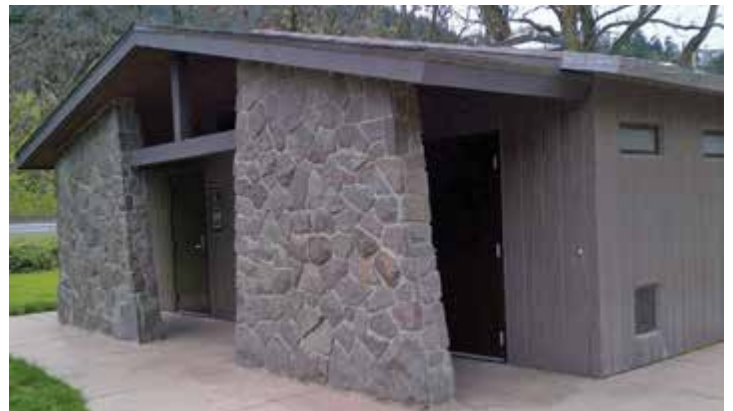
Flush restroom with custom covered entry

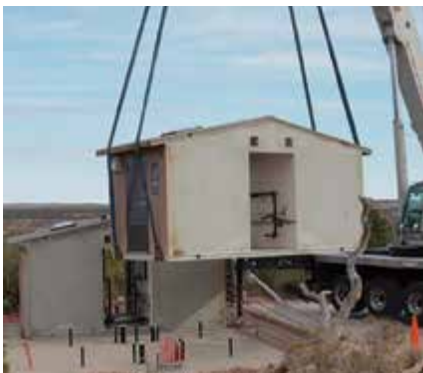
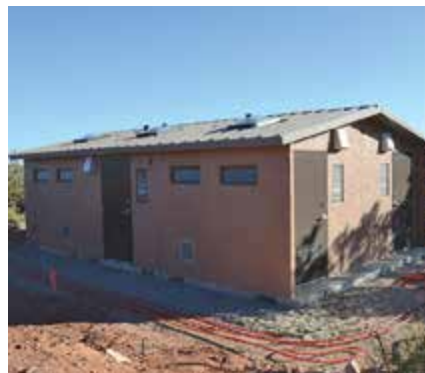
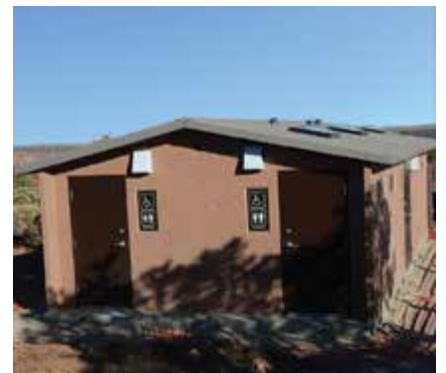
Pre-engineered plumbing and electrical for easy placement. The sections are wired and tensioned together, caulked and sealed for a seamless fit.
